INCIDENT INVESTIGATION REPORT

Notice of incident number 2009113820050	Date of incident February 22, 2009	Location of incident Montrose site Toba Inlet area, B.C.
Lead investigating officer Barbara Deschenes	Investigation file number 2009-166	Incident outcome FATAL
Report approved by manager, Fatal and Serious Injury Investigations John Eldridge	Signature 	Date March 31, 2010

On February 22, 2009, at approximately 13:00, a large rock rolled downhill on a run-of-the-river project construction site located near the headwaters of Toba Inlet. The rock struck a scaler as he hand drilled a boulder to prepare it for blasting. The scaler, a young worker, immediately sustained fatal head injuries.

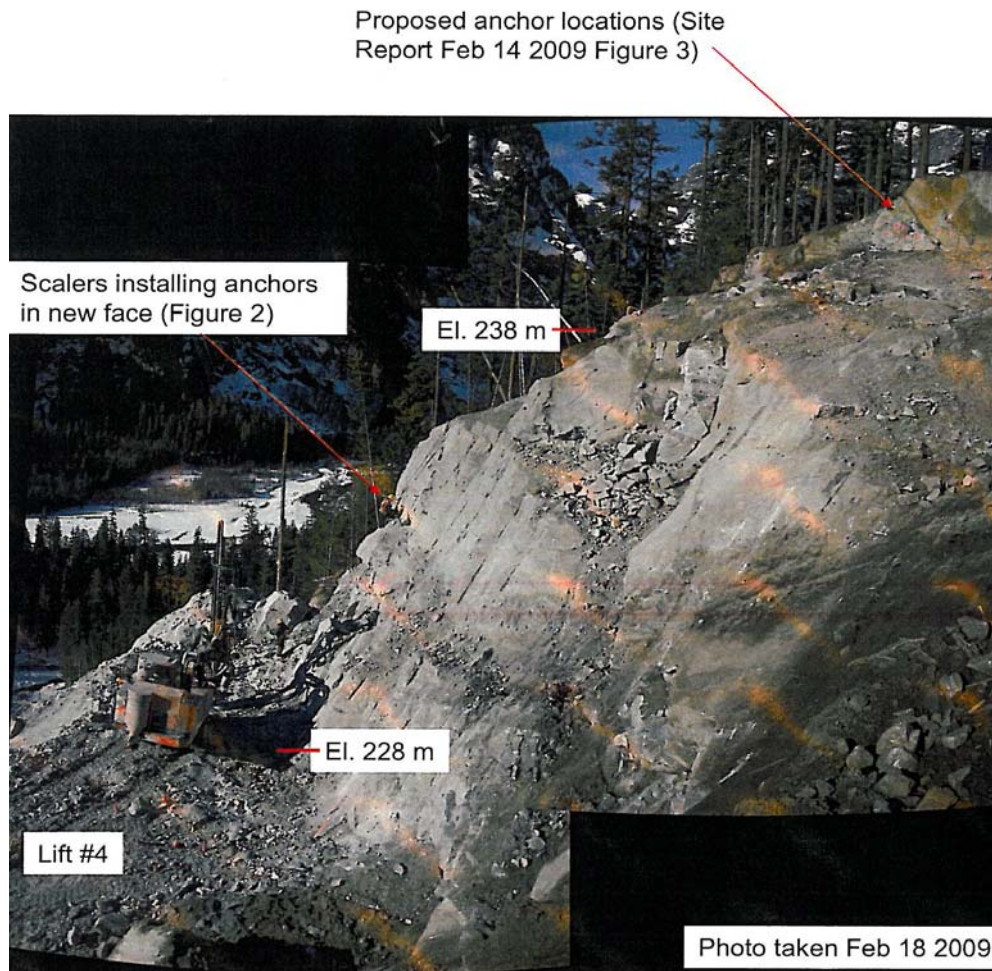
Tank drilling pre-shear and production holes on Lift #4. It was planned to shoot holes on Feb 19 2009 morning.

Figure 3. *Wyllie Norrish photograph. Ranger drill on Bench 4 on February 18, 2009. Note: Wyllie Norrish inserted the labels and caption in this photograph and in the Figure 4 photograph.*

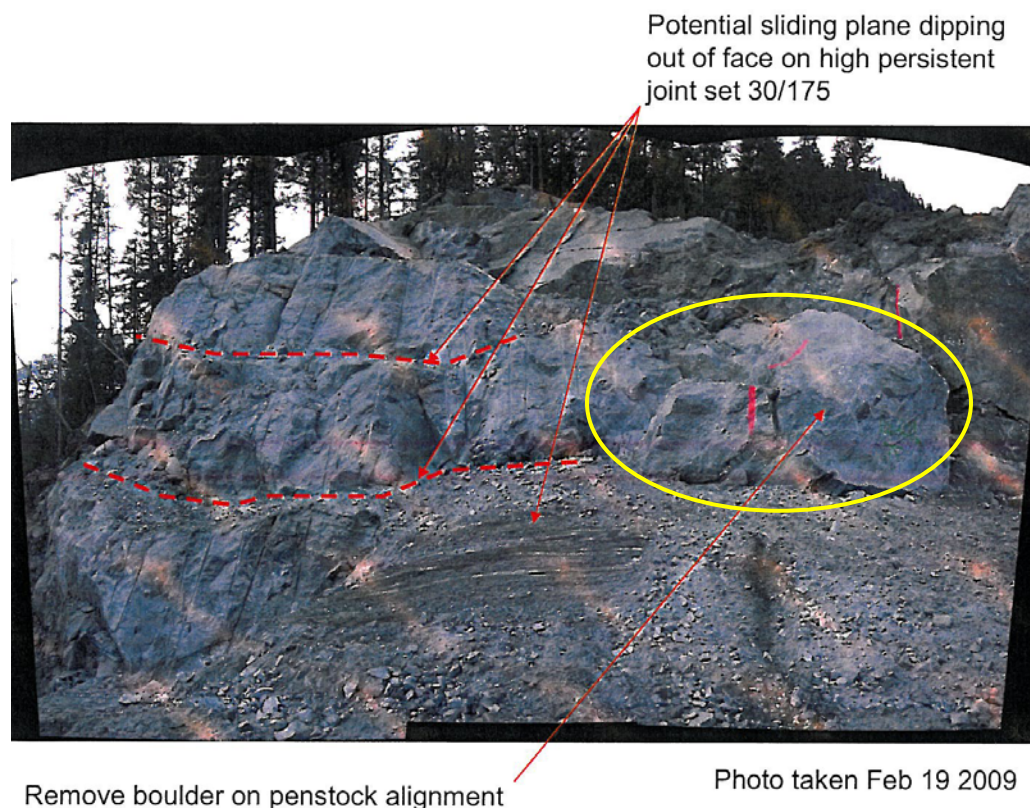
During the February 17–20 geotechnical inspection, Geotechnical Engineer 2 photographed a large boulder located uphill from Bench 4. Geotechnical Engineer 2 advised the removal of the boulder because it was on the penstock alignment (see Figure 4).

Figure 4. *Wyllie Norrish photograph. The inserted circle indicates the boulder that lay upon the penstock alignment approximately 10 metres uphill from Bench 4. Note the trough-like topography at the crest of the hill directly above the boulder. This boulder was the location of the fatal incident on February 22, 2009.*

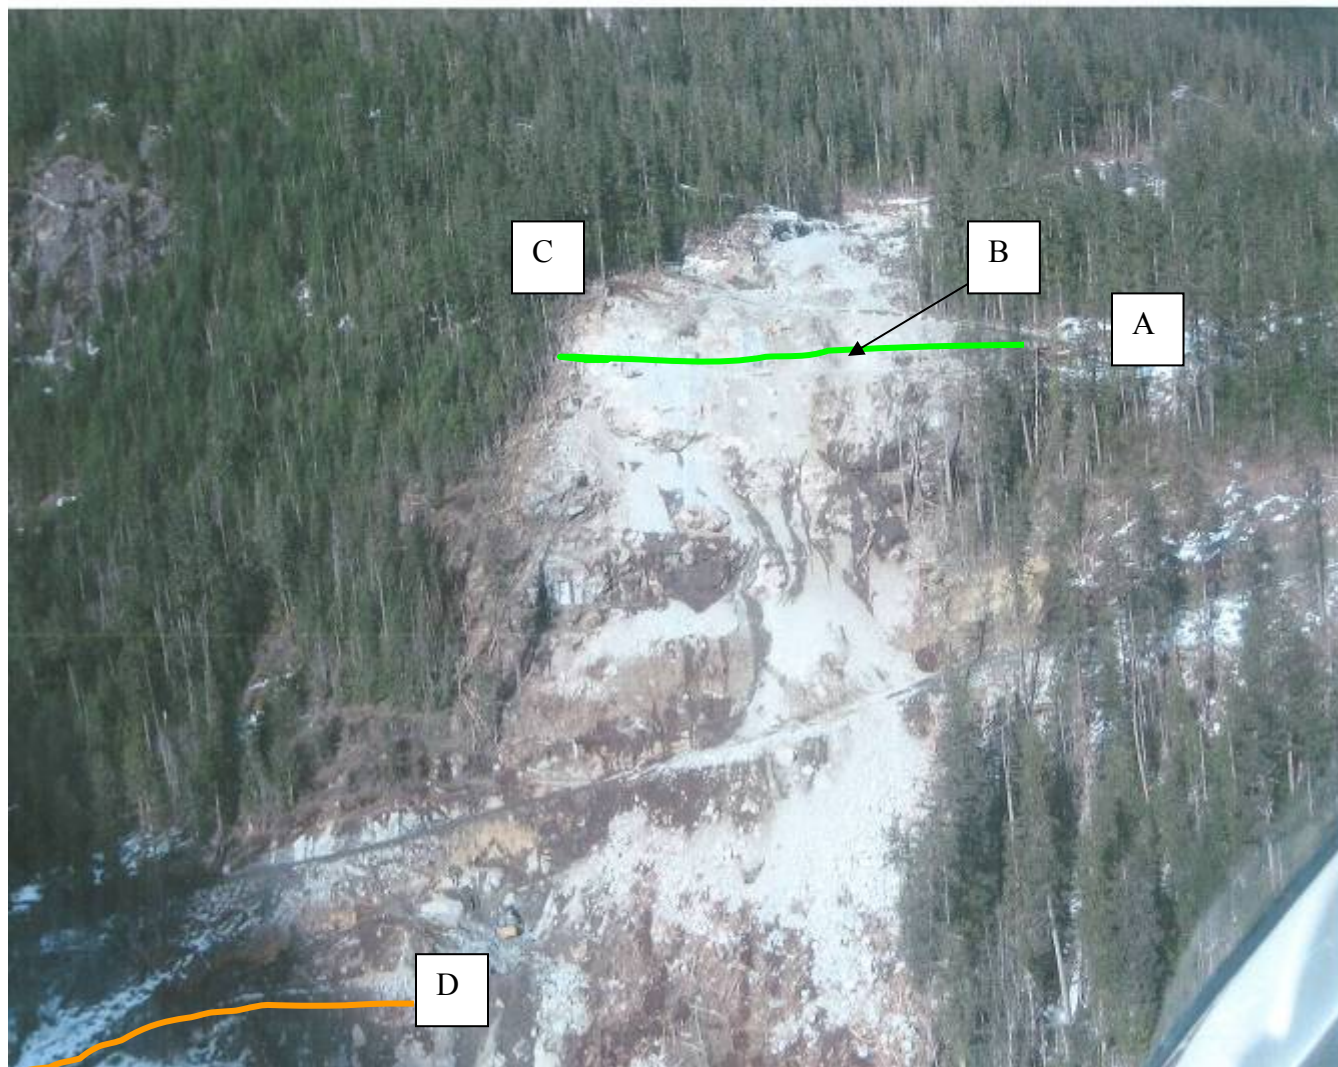
Notably, the inspection of the worksite following the February 21 incident did not include an examination of the terrain above the top of the rock cut for unstable material in that area.

Figure 5. Undated Kiewit aerial photograph of site. Box A shows the location of the Bench 4 access road (green line). Box B indicates the location of the Excavator Operator near the outer end of the Bench 4 access road. Box C shows the scalers' location above Bench 4. Box D indicates the location of the Bench 21 access road (orange line) and the crews working on Bench 21. It is not known with certainty whether the boulder in the February 21 incident originated from the area above Bench 4 or from below Bench 4, but it was observed rolling in the area near where the excavator was working.

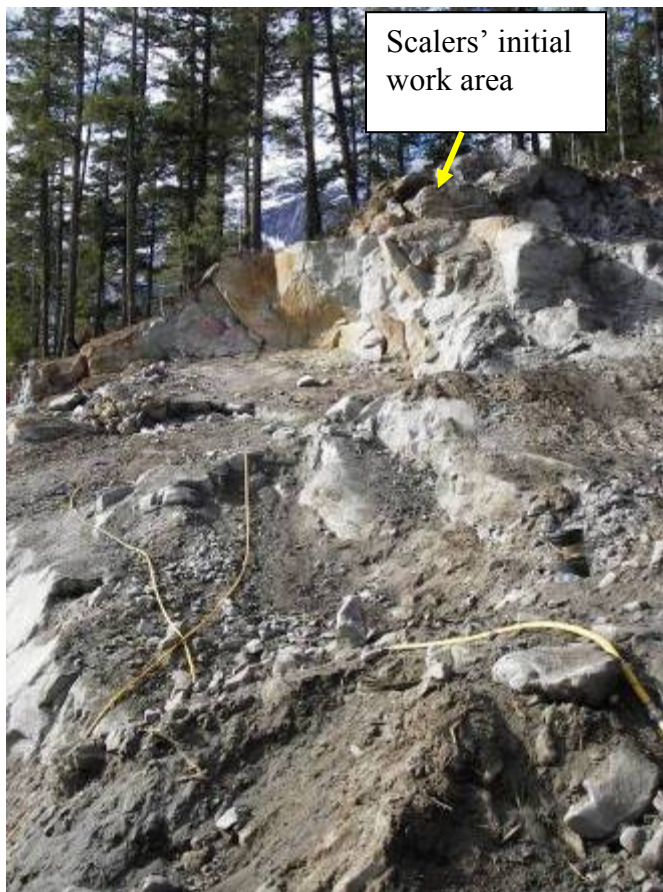
Figure 6. The compressor air line the scalers moved from tree line area to the boulder. The boulder was below the air line in the lower left corner of the photograph. Note the loose rocks near the air line.

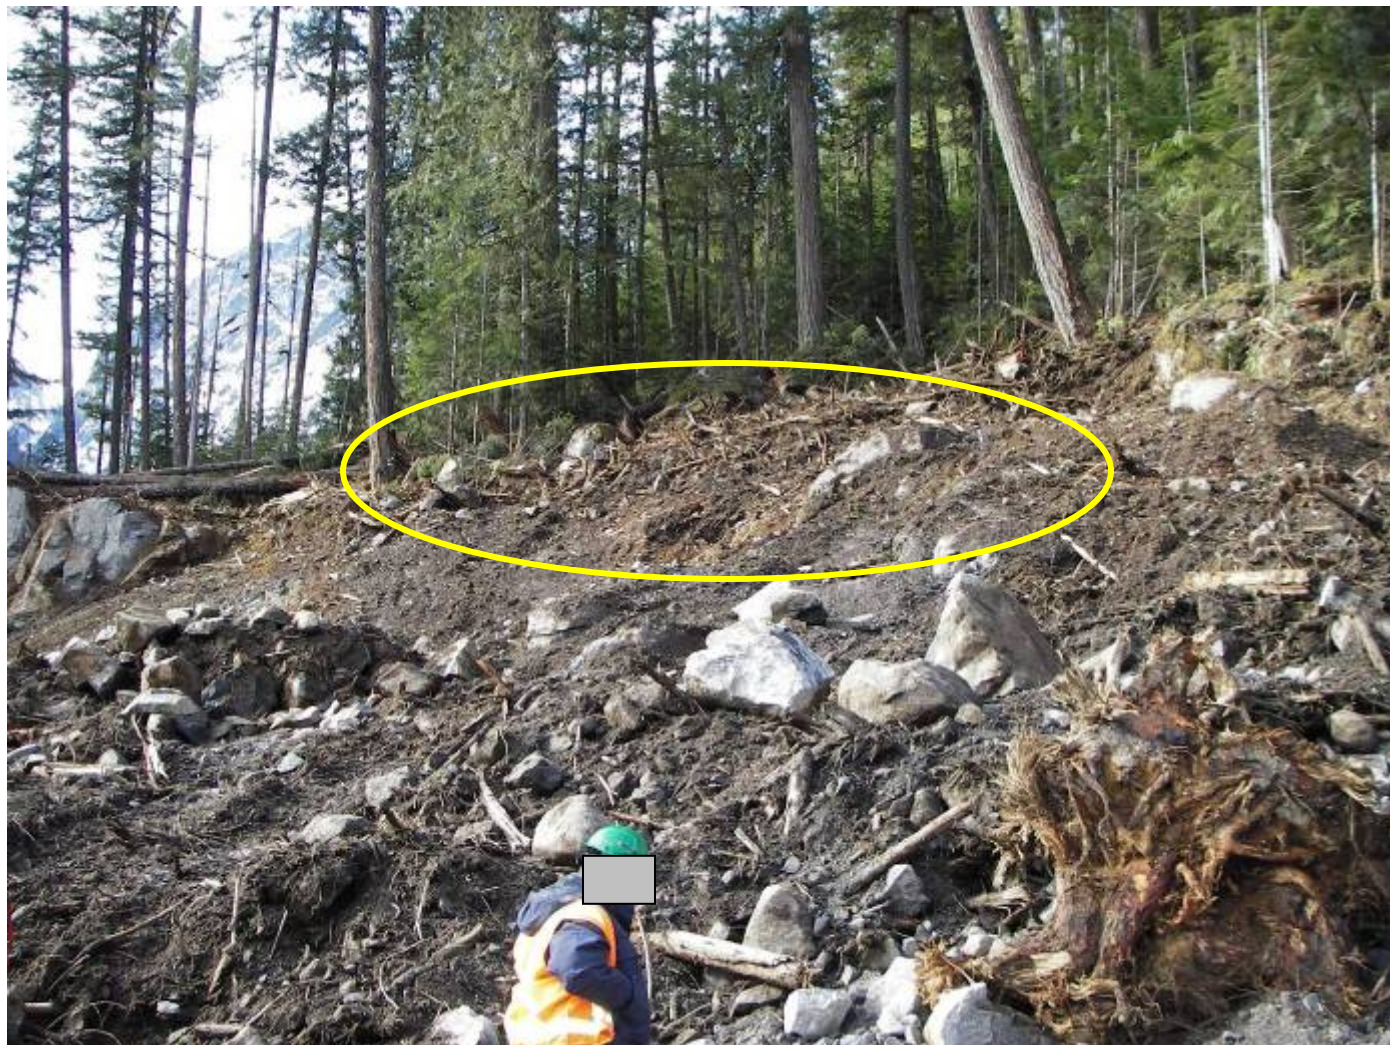
Figure 7. Rough area adjacent to previously machine-scaled ground.

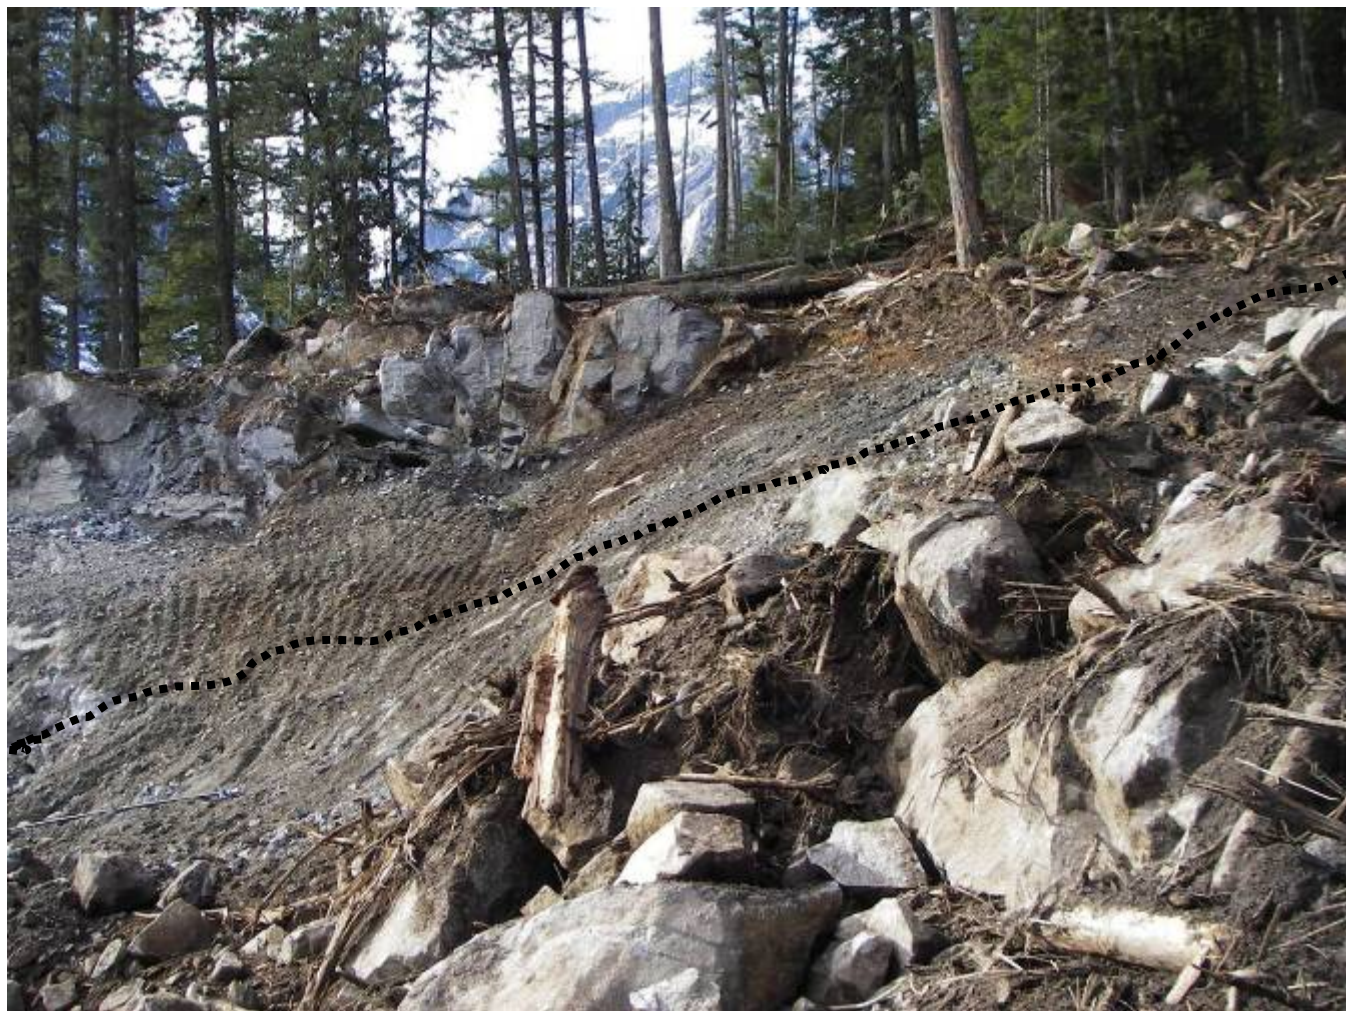
Figure 8. *Previously machine-scaled area. The dotted line indicates the rock's path that the Excavator Operator described.*

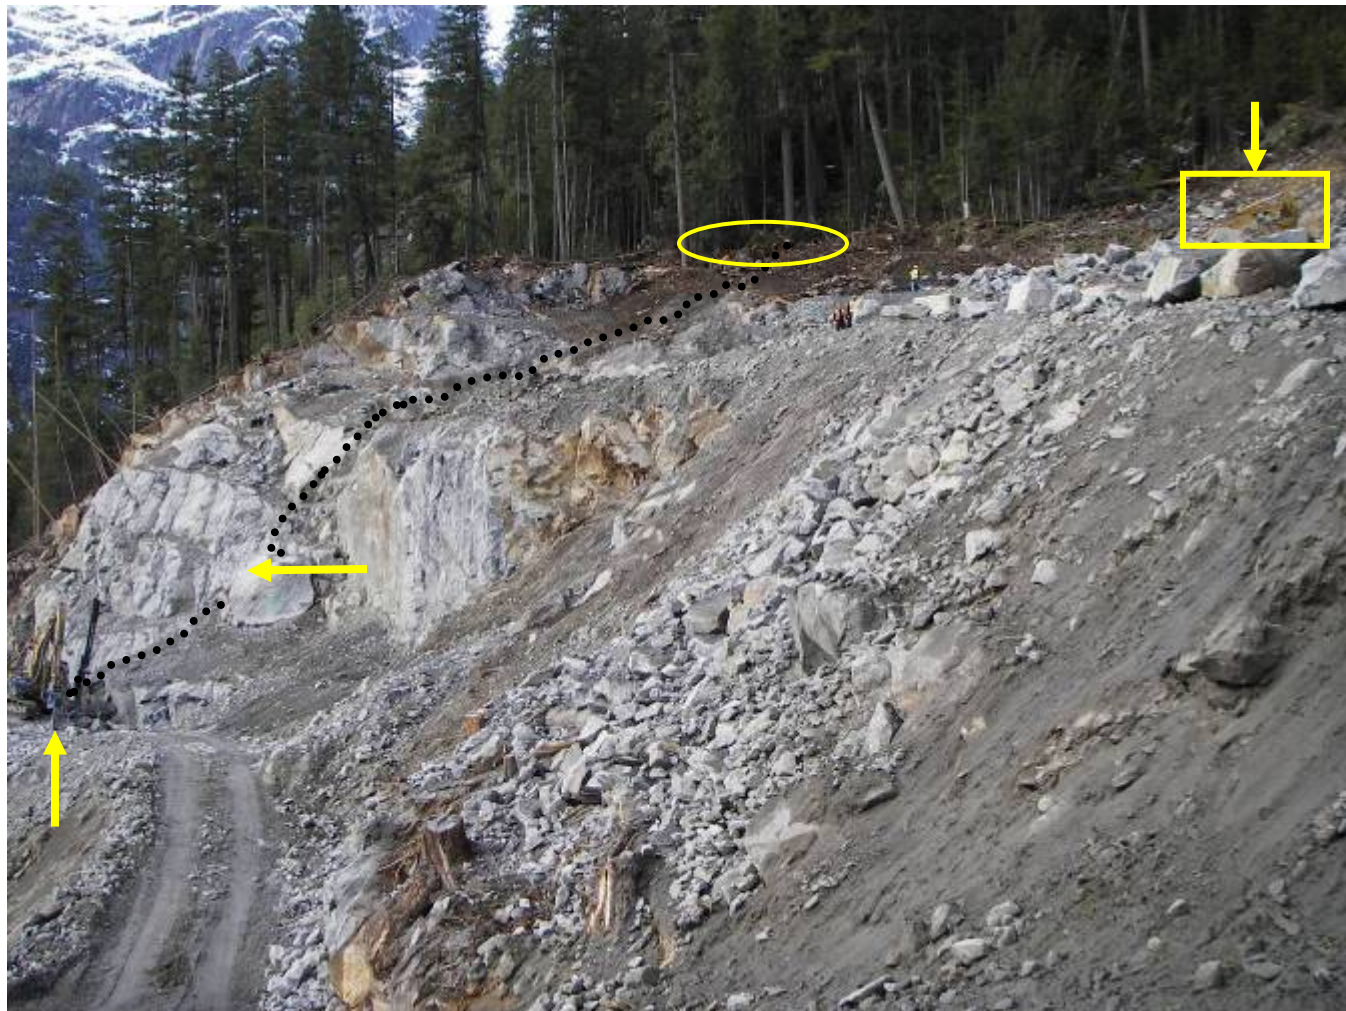
Figure 9. Overview photograph of fatal incident area. The dotted line indicates the path of the rock that the Excavator Operator and the drilling crew described. The area within the oval at the tree line is where the Excavator Operator first saw the rolling rock. The downward arrow points to the Excavator Operator's machine, which is in the area within the rectangle. The horizontal arrow points to the fatality scene. The upward arrow points to the hoe drill.

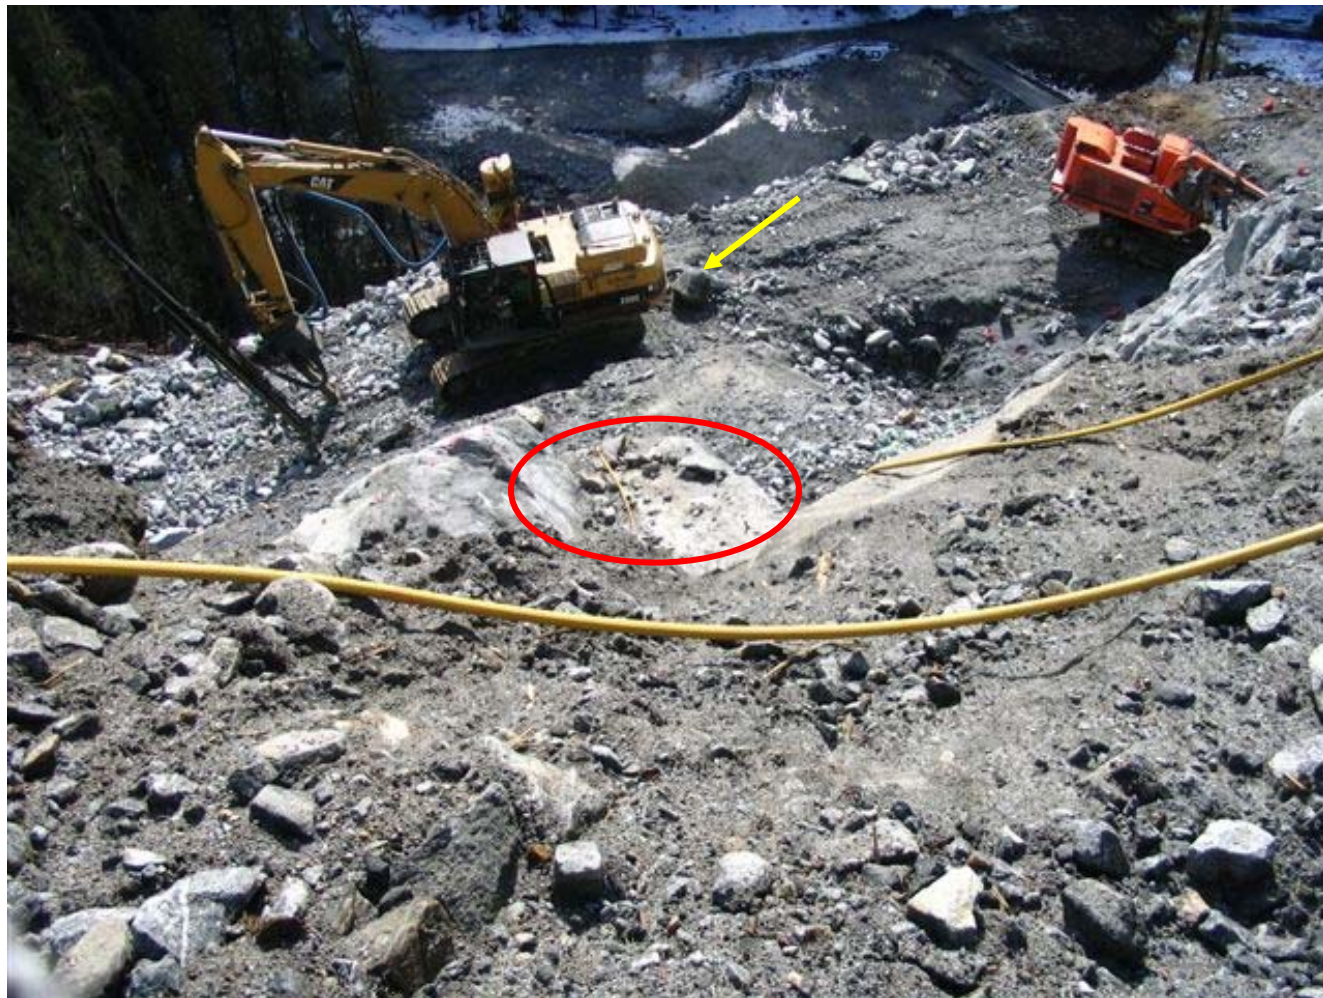
The rock partially fragmented after striking Scaler 1 and the boulder he had been drilling, but a large portion of the rock continued to come directly toward the hoe drill. The Blaster looked toward the area and saw the Hoe Drill Operator rapidly move from near the hoe drill's left track to escape being struck by the rock by taking shelter beside the rock face. Scaler 2 remained in the cab of the hoe drill. The rock struck the track of the hoe drill and split apart into several pieces. Some of the rock's fragments remained beside the hoe drill's left track and the rock face, and a large portion landed behind the rear of the hoe drill (see Figures 10 and 11).

Figure 10. Fatality scene indicated by the circled area. The rock split apart during the incident. Some of the rock's fragments remained on the boulder. The arrow points to one of the rock's fragments that landed behind the hoe drill.

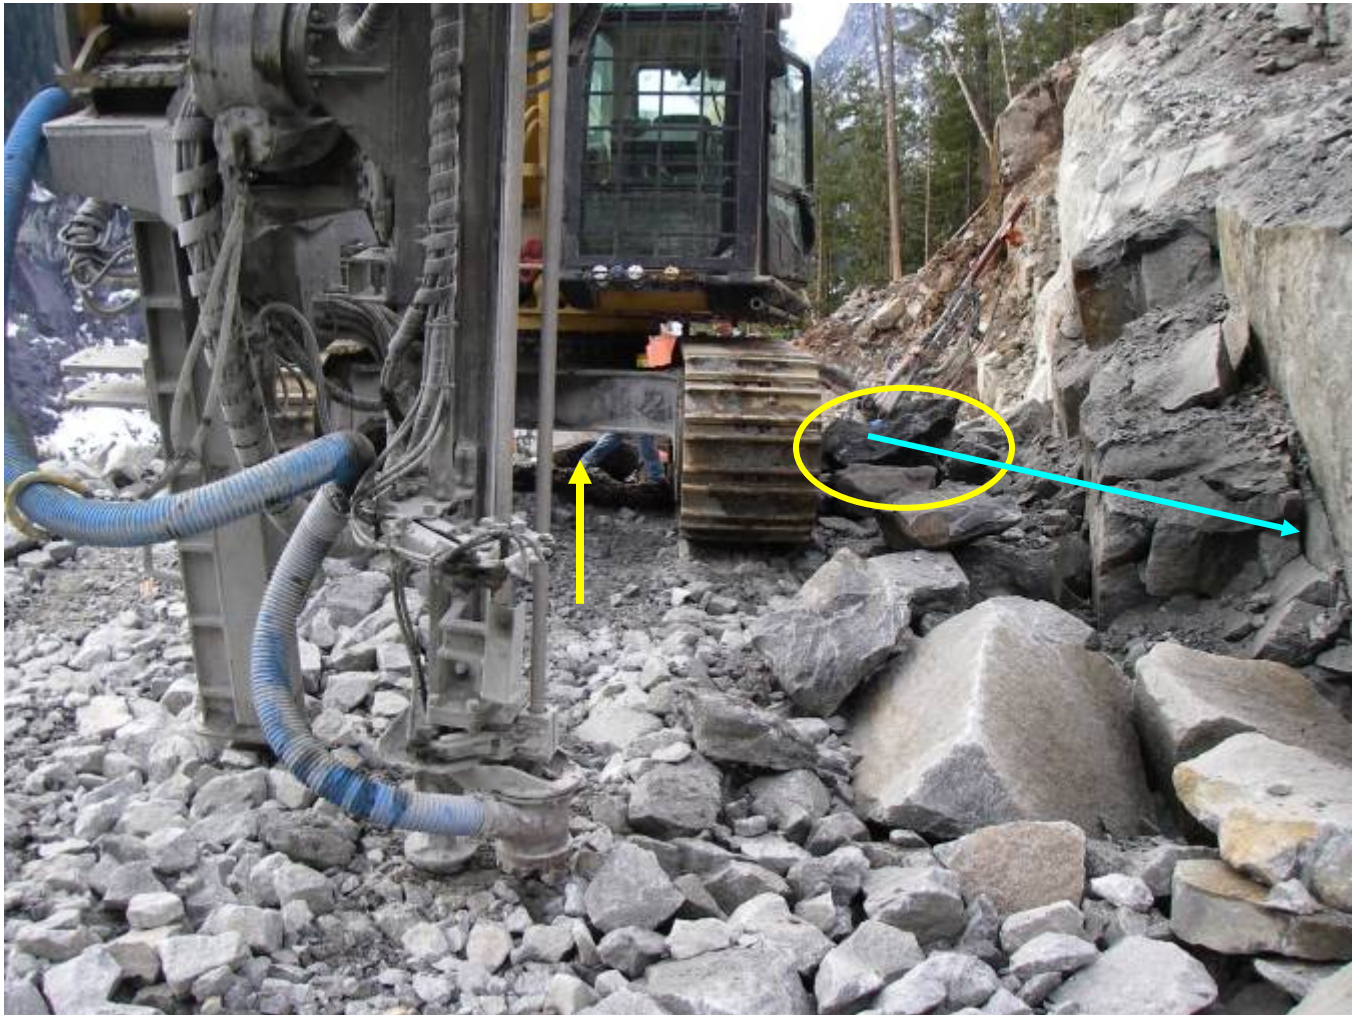
Figure 11. Rock fragments between the left track of hoe drill and the rock face are circled. The blue arrow points to where the Hoe Drill Operator moved to take shelter from the rolling rock. The yellow upward arrow points to the rock fragment behind the hoe drill.

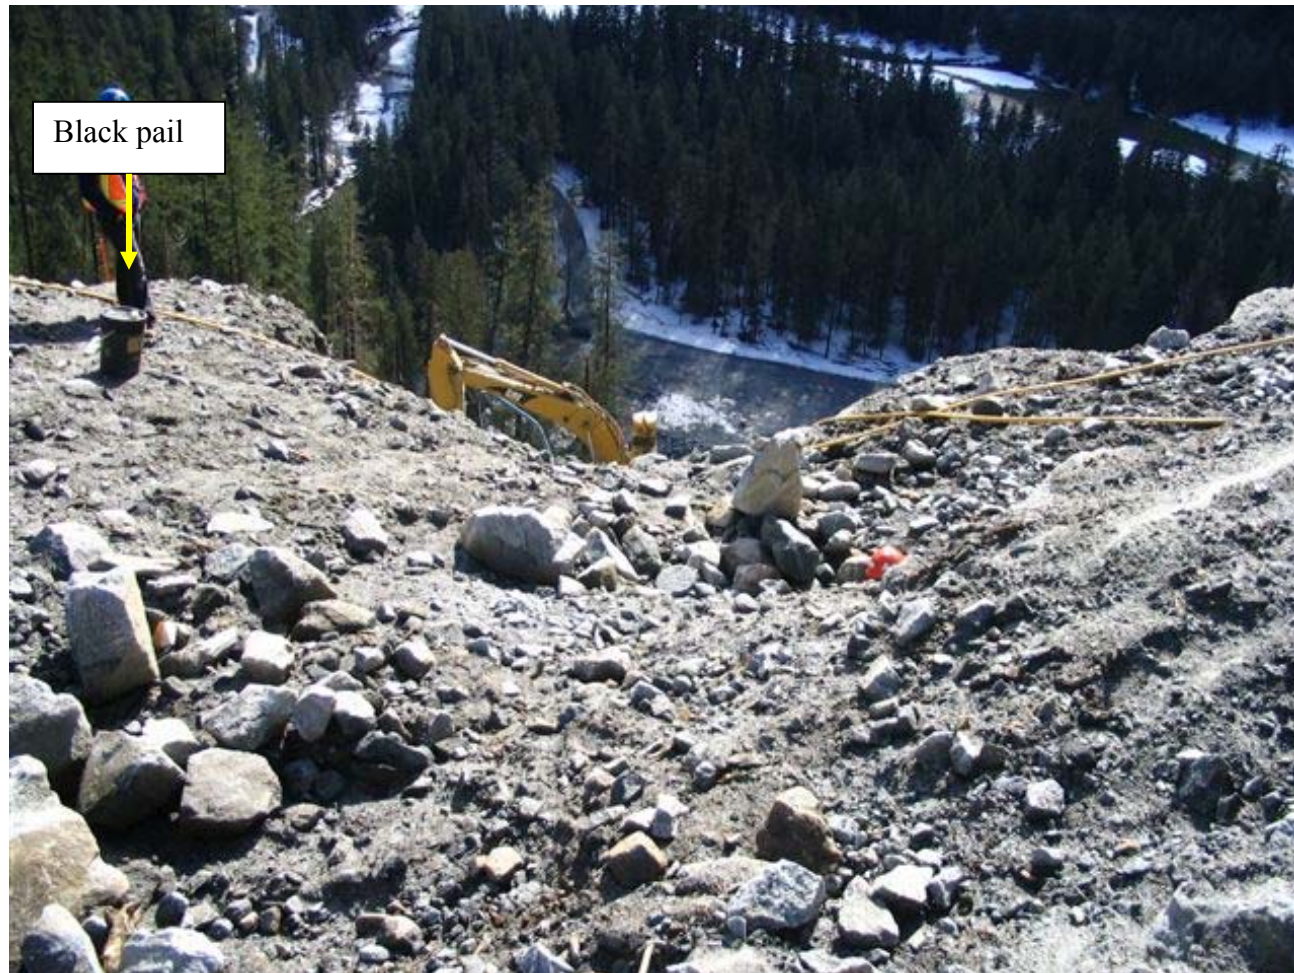
Above Bench 4, there was a significant trough-like depression in the ground (see Figure 12). Persons interviewed were aware of the presence of this trough and further understood that material that rolled in the area and entered the trough would likely roll farther onto Bench 4. The terrain above the crest of the hill sloped to varying degrees in different locations; Kiewit engineering personnel estimated that the area where the rock was seen rolling had a slope of 30 to 35 percent.

Figure 12. Trough above Bench 4. The rock rolled down the trough and beside the black pail. The upper components of the hoe drill (still where it was parked when the fatality occurred) are visible near the centre of the photograph.

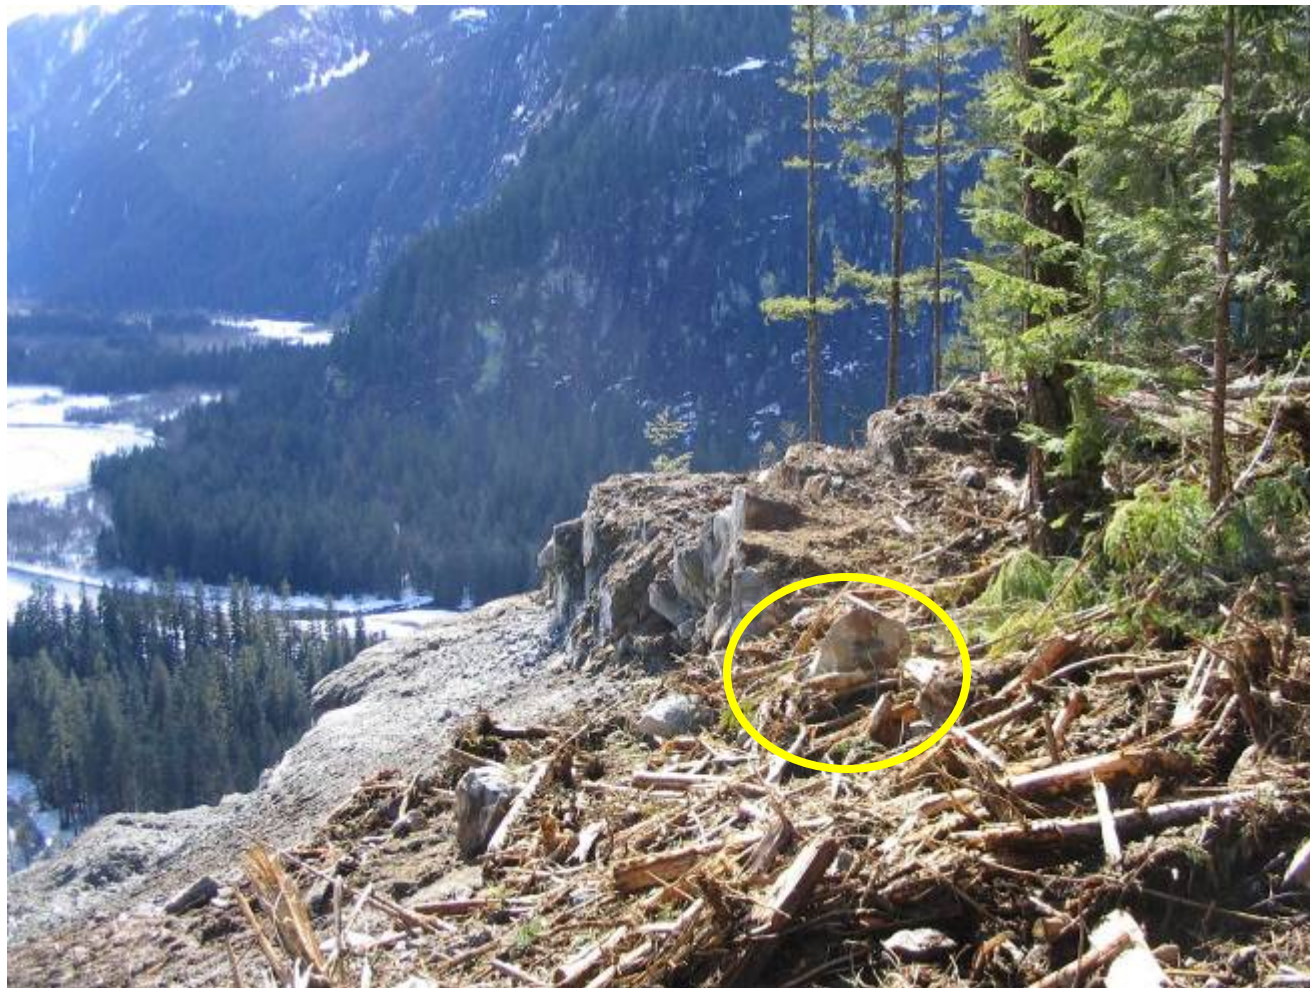
Some of the larger rocks near the tree line area were on top of disturbed ground and forest debris that afforded little surface stability (see Figure 13). Equipment track marks and the fresh appearance of disturbed ground indicated that mobile equipment operation had recently disturbed some of the loose materials.

Figure 13. *Unstable materials adjacent to area previously machine-scaled. A rock lying upon loose forest debris is circled.*

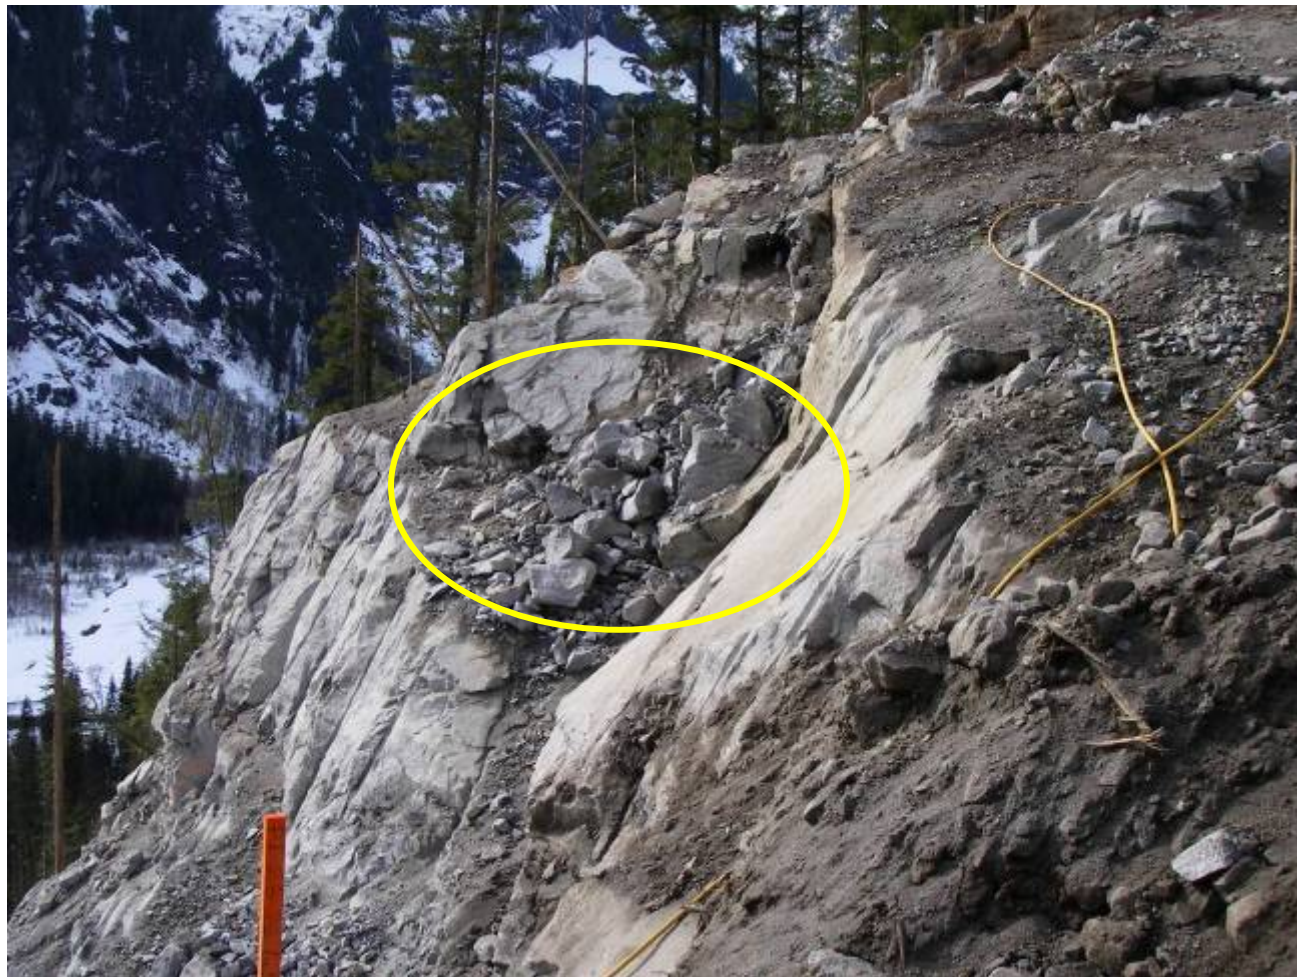
On the rock face above where the drillers and scalars drilled, and above where others, such as the Kiewit engineers, the Blaster, and the survey crew had worked, there were unscaled rocks on the uphill face of the rock cut (see Figure 14). This same loose material was present and shown on the February 18 photograph taken by Geotechnical Engineer 2 (see Figure 3). In his inspection report, the engineer had recommended that the full face be scaled.

Figure 14. *Loose unscaled rock above the Ranger Drill Operator's location.*

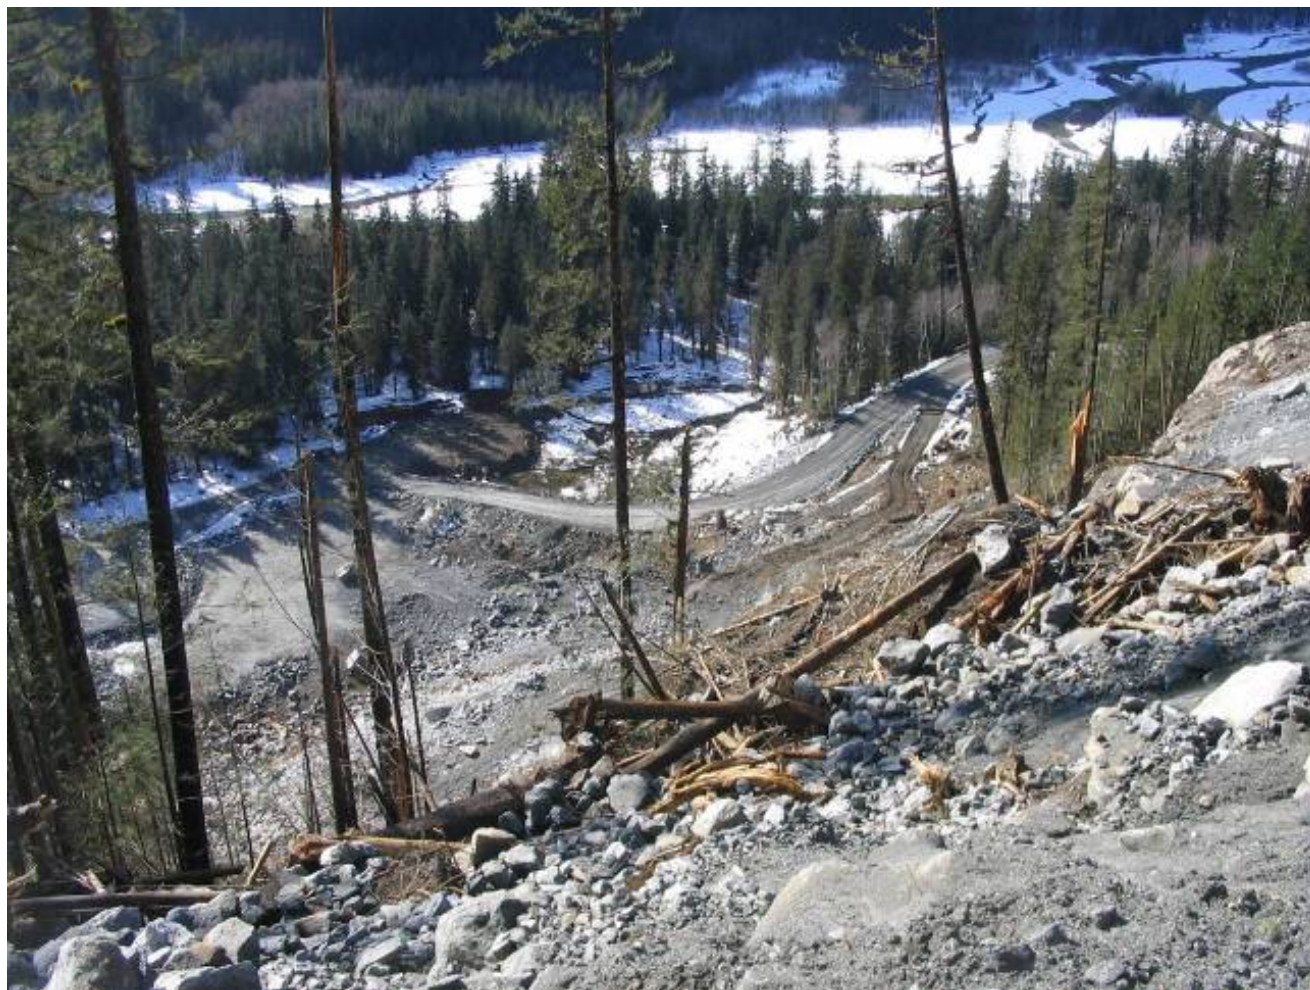
Below the access road to Bench 4, and above the main access road to the site, there were loose rocks, forest debris, and logs (see Figure 15). These materials presented falling material hazards to persons travelling on roads or working below them.

Figure 15. Unstable rock, forest debris, and logs below the Bench 4 access road and above the main access road.
