Klohn Crippen Berger

Red Chris Mine Site

Review of Tailings Impoundment Design

October 10, 2014

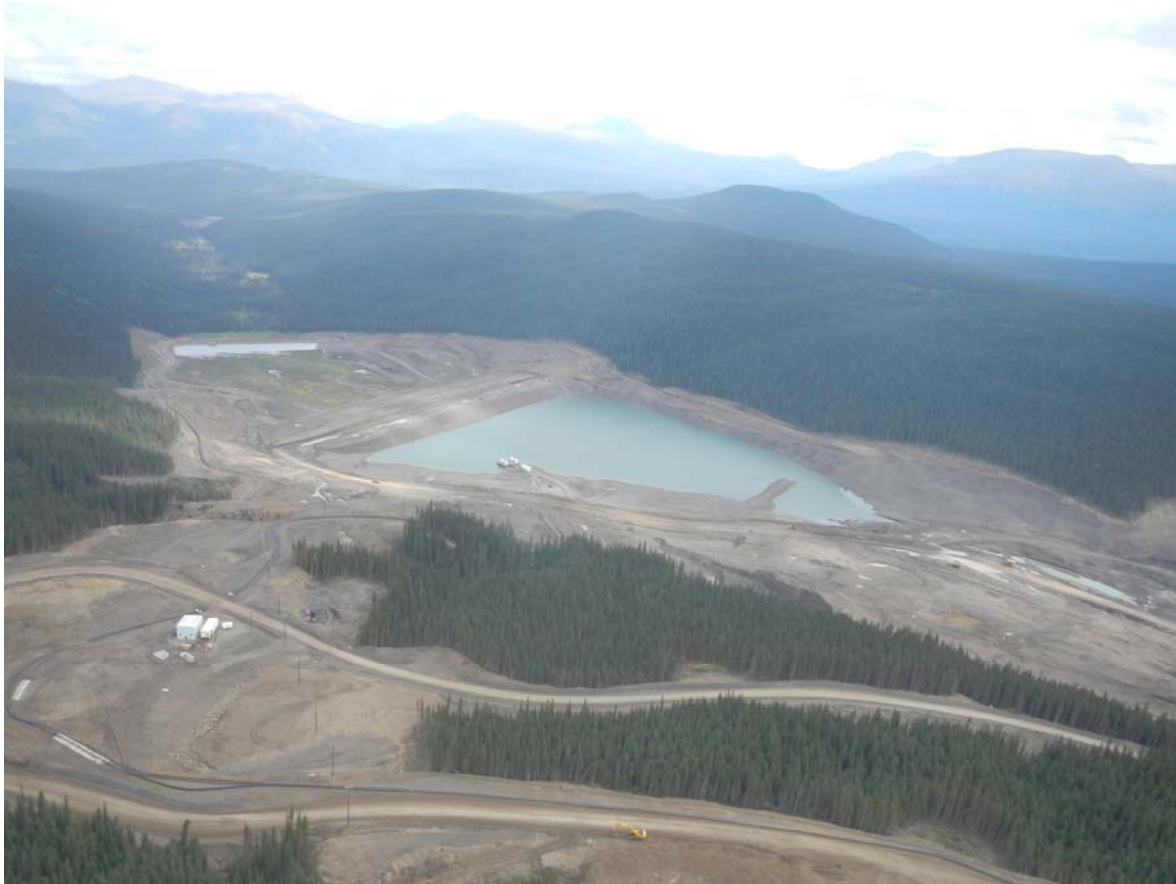
Figure 3.1 North Starter Dam

Table 1.1. Our review of the adequacy of construction is limited to our field inspection, conversations with BGC staff, and reading of the aforementioned report. The design section and slopes are appropriate for a starter dam in this context. There are no signs of settlement, slope bulging, cracking or other indications of instability evident at the dam. The dam appears well-constructed.

We are aware that the fines content for Zone 3A was increased, 5% to 6.5%, during construction in 2013 because the sand and gravel broke down slightly during construction. The compaction specification for Zone 3A was changed to minimize crushing of sand grains. Fines contents in filters/drains are normally kept to less than 5%, sometimes 3%, to ensure that the filter/drain has the drainage capacity to convey seepage from the impervious zone to the toe of the dam. The increase in fines in this case will reduce the capacity of the drain but tailings will envelope the dam long before the full capacity of the drain is required. The second reason for limiting fines content is to prevent a crack in the core or Zone 1 progressing through the drain and thereby bypassing its function. Cracks most often occur in dams that are poorly compacted, are on compressible foundations, or on foundations where the underlying rock profile changes rapidly. None of these operate at this site so we do not consider that the increase in fines content will impair the function of the drain.

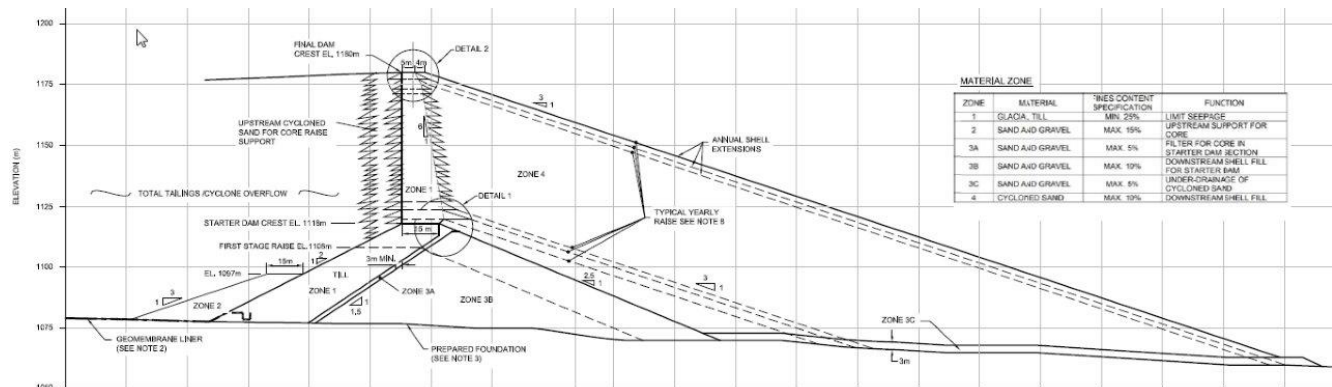
Figure 5.1 Final Design Section for North Starter Dam

The basic tailings dam design, as shown in section on Figure 5.1 is to raise the north and south dams using centerline construction above the starter dam. What follows is a description of our understanding of the design and operation of the North Dam. The South Dam is a similar design, except that there is presently no plan to include a core in this dam.

A compacted glacial till core will be raised with the dam to reduce seepage in the downstream cell constructed zone. Except for a drain on the foundation from the downstream toe of the starter dam to the downstream toe of the hydraulic fill section, no other drains/filters are planned for the downstream hydraulic fill section. As described in Section 3, the blanket foundation drain downstream of the North Starter Dam is an important element that still requires detailed design.

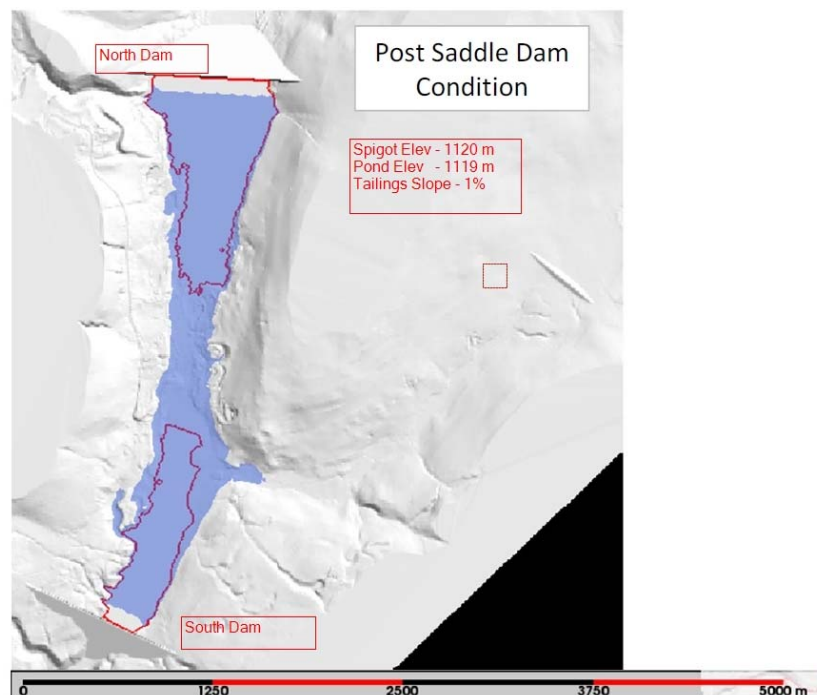
Figure 5.2 Tailings Deposition from Muck 3D at El. 1120 m

The illustration below (Figure 5.2) shows the extent of the water pond and the red tailings outline at 1120 m. This is for a tailings slope overall of 1%, a beach width of 100 m and no PAG tailings deposition. If the tailings slope were flatter then the unlined water pond outline will be less. The steeper the subaqueous tailings slope the greater the free water pond size (without tailings liner). This simple illustration demonstrates that seepage loss estimates are dependent on the deposition plan.

A large area upstream of the NSD has been opened up for borrow of dam materials. These areas should be mapped and correlated with the existing geologic model. In addition, the surface should be scoured for open work gravels where tailings could be lost to the pervious foundation soils. This surficial geological mapping exercise should be used by the designers to confirm that the tailings will not pipe into the pervious foundation soils. The water balance and seepage models need to be continually updated to confirm the integrity of the tailings liner.
