Subject: Toba Montrose Fatal Scaling Incident – February 22, 2009

INTRODUCTION

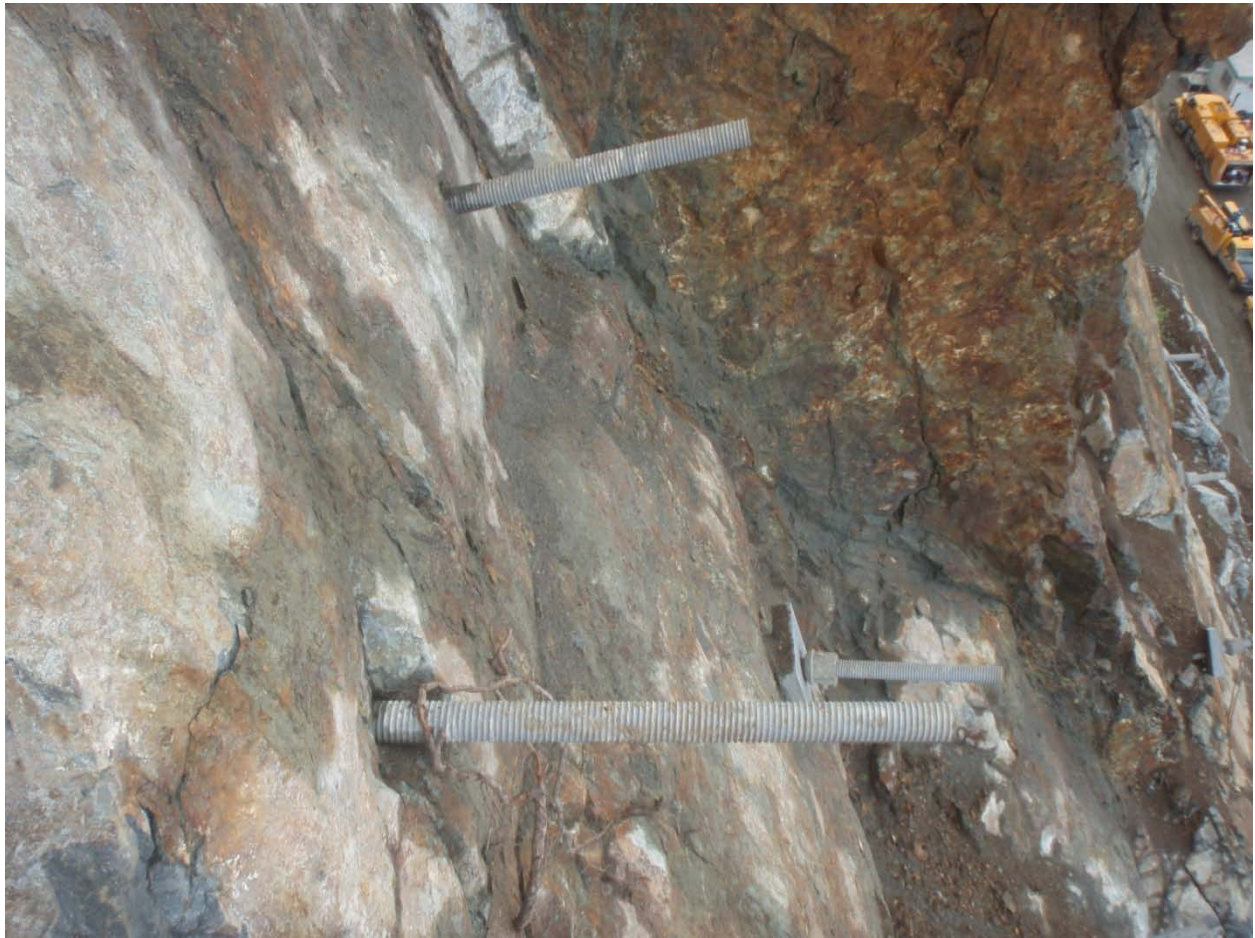
1. Over 23 of the rock bolts were not fully encapsulated with grout to ensure proper bonding.
2. The majority of rock bolts did not have nuts or plates on the anchors
3. Nearly all the anchors were not tensioned to apply tension on the slope to prevent movement of the rock
4. A majority of the anchors were not even grouted.

Figure 1. Anchors with no plates or grout on Cut 9, Segment 1. These anchors are to be tensioned rock bolts.

We reported the issues to Kiewit management and the issues were ignored. When I had questioned Kiewit personnel on the site about the quality of the bolt installations, they were not surprised; as the scaling crew for Segment 1 was not given ample time to correctly install the rock bolts. I was informed that the excavation operation was given priority over the scalers. I took photos of the rock bolts during the inspection of the cut to provide to Kiewit and nothing was ever done to repair the bolts.
